Tree Risk Assessment and Management Report

Site: Tree Climb, Botanic Gardens Bat Loop

Date: Friday, 21 July 2023

ATS7341-ABGBatLoopTRAM

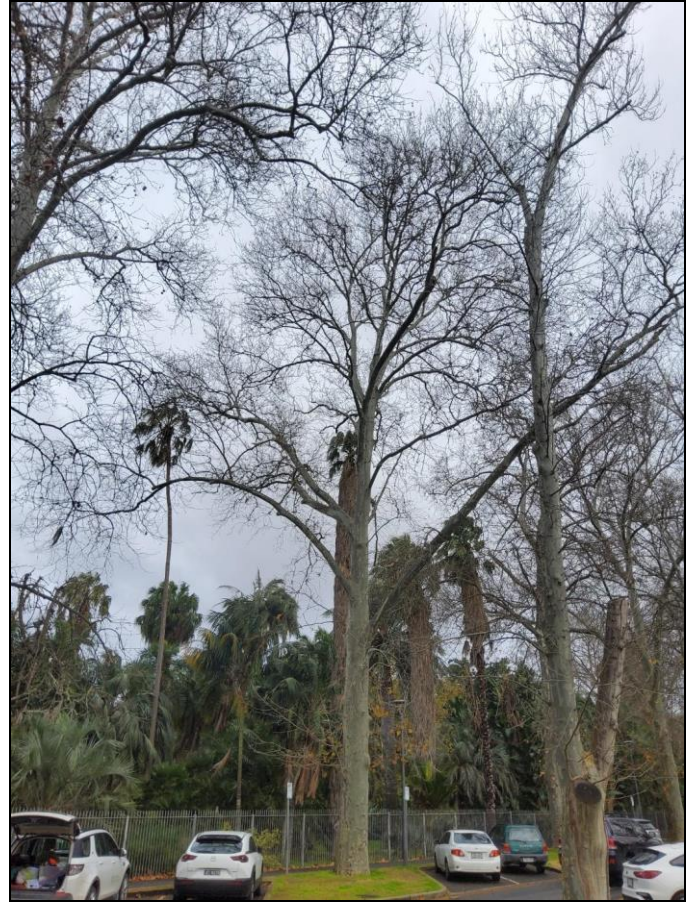
London Plane

Inspected:	6 July 2023
Height:	>20 metres
Spread:	>20 metres
Health:	Good
Structure:	Good
Form:	Good
Trunk Circumference:	>3 metres
Useful Life Expectancy:	>20 years

The health and structure of this tree indicate it is in good overall condition and has adapted to its local environment.

A Likelihood of Failure and Impact of "Unlikely" and a Consequence of "Minor" when combined in the Risk matrix achieve a Risk Rating of "Low".

No remedial action is currently recommended.

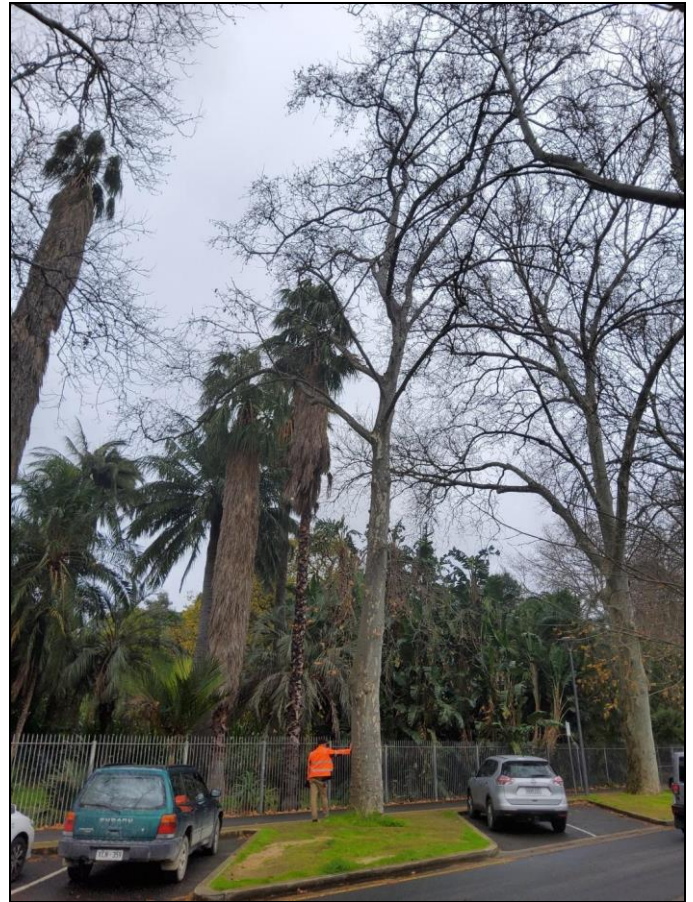
London Plane

Inspected:	6 July 2023
Height:	>20 metres
Spread:	>20 metres
Health:	Good
Structure:	Good
Form:	Good
Trunk Circumference:	>2 metres
Useful Life Expectancy:	>20 years

The health and structure of this tree indicate it is in good overall condition and has adapted to its local environment.

A Likelihood of Failure and Impact of "Unlikely" and a Consequence of "Minor" when combined in the Risk matrix achieve a Risk Rating of "Low".

No remedial action is currently recommended.

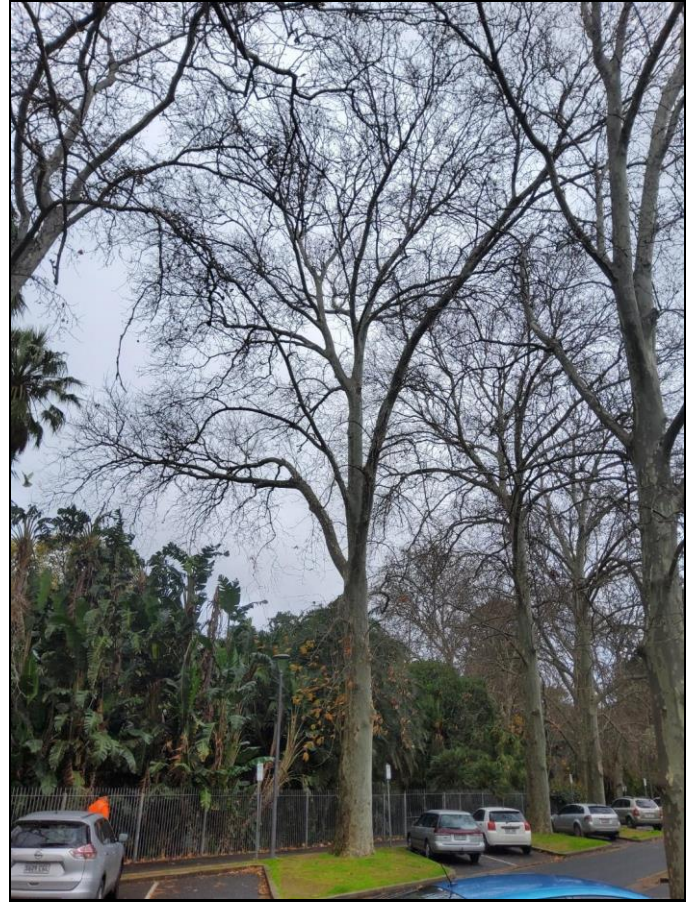
London Plane

Inspected:	6 July 2023
Height:	>20 metres
Spread:	>20 metres
Health:	Good
Structure:	Good
Form:	Good
Trunk Circumference:	>3 metres
Useful Life Expectancy:	>20 years

The health and structure of this tree indicate it is in good overall condition and has adapted to its local environment.

A Likelihood of Failure and Impact of "Unlikely" and a Consequence of "Minor" when combined in the Risk matrix achieve a Risk Rating of "Low".

No remedial action is currently recommended.

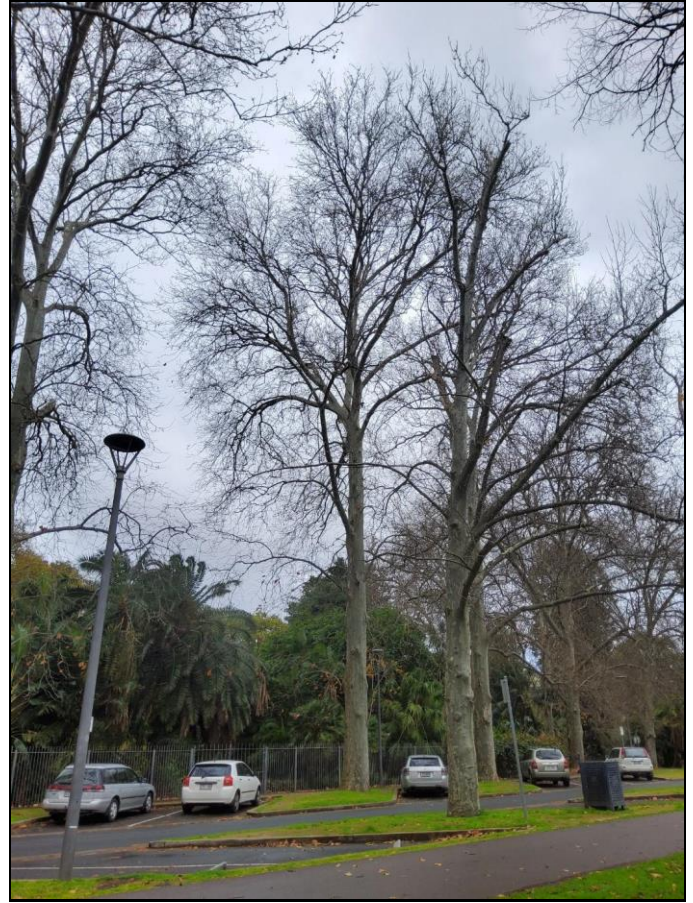
London Plane

Inspected:	6 July 2023
Height:	>20 metres
Spread:	>20 metres
Health:	Good
Structure:	Good
Form:	Good
Trunk Circumference:	>3 metres
Useful Life Expectancy:	>20 years

The health and structure of this tree indicate it is in good overall condition and has adapted to its local environment. There are hollows high in the leading stem however this is not impacting the overall structure of the tree.

A Likelihood of Failure and Impact of "Unlikely" and a Consequence of "Minor" when combined in the Risk matrix achieve a Risk Rating of "Low".

No remedial action is currently recommended.

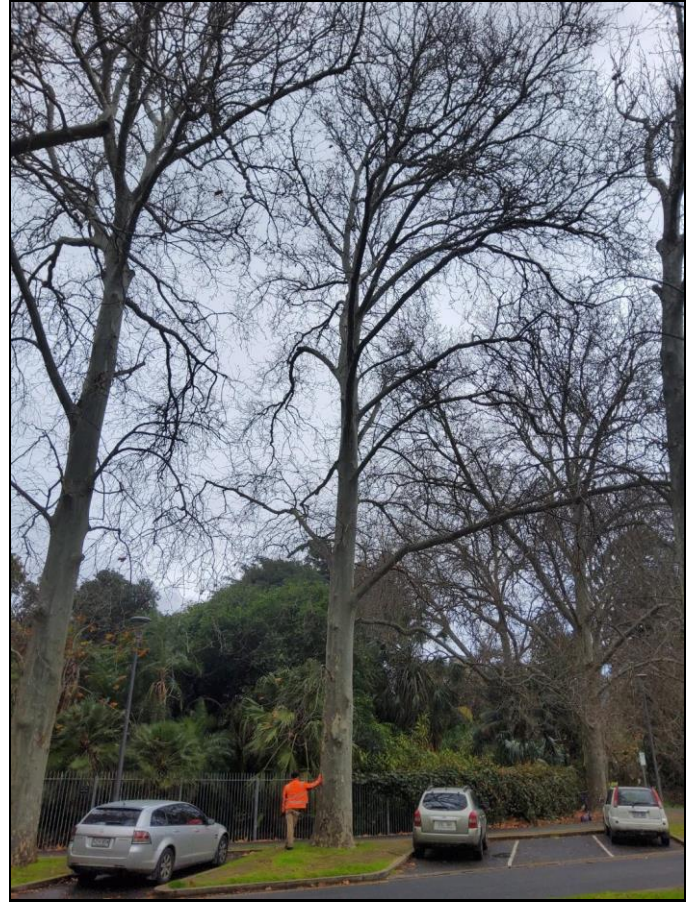
London Plane

Inspected:	6 July 2023
Height:	>20 metres
Spread:	>20 metres
Health:	Good
Structure:	Good
Form:	Good
Trunk Circumference:	>2 metres
Useful Life Expectancy:	>20 years

The health and structure of this tree indicate it is in good overall condition and has adapted to its local environment. There is some damage from bird activity to the leading stem and primary branch unions in the upper crown however this is not impacting the overall structure of the tree.

A Likelihood of Failure and Impact of "Unlikely" and a Consequence of "Minor" when combined in the Risk matrix achieve a Risk Rating of "Low".

No remedial action is currently recommended.

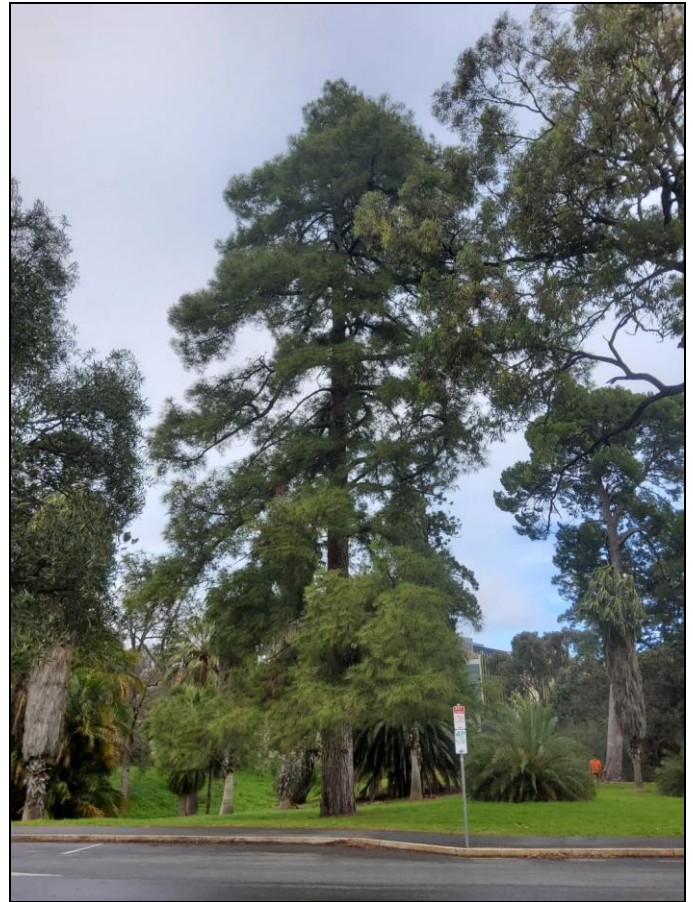
Canary Island Pine

Inspected:	6 July 2023
Height:	>20 metres
Spread:	>20 metres
Health:	Good
Structure:	Good
Form:	Good
Trunk Circumference:	>3 metres
Useful Life Expectancy:	>20 years

The health and structure of this tree indicate it is in good overall condition and has adapted to its local environment. This tree is identified as part of the bat roost and is marked as Tree 154.

Legislative Status	Exempt
Trees on this site are exempt from control under the Planning, Development and Infrastructure Act 2016 as per Schedule 4—Exclusions from definition of development—general, Part 18, (1), (d) of the Planning, Development and Infrastructure (General) Regulations 2017.	
Risk Rating	Low
A Likelihood of Failure and Impact of "Unlikely" and a Consequence of "Minor" when combined in the Risk matrix achieve a Risk Rating of "Low".	
Action	No Action
No remedial action is currently recommended.

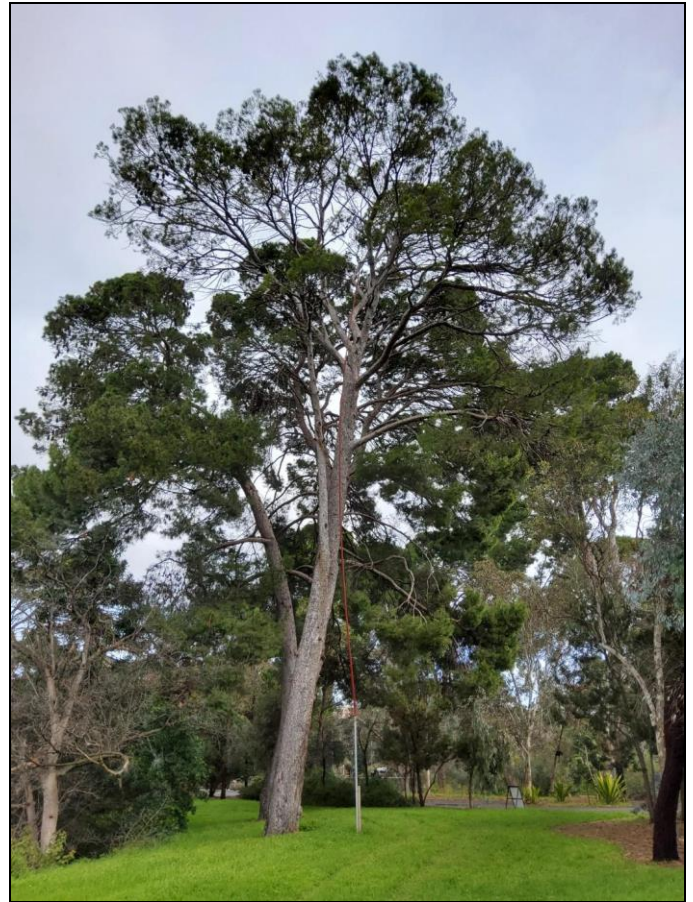
Aleppo Pine

Inspected:	6 July 2023
Height:	>20 metres
Spread:	>20 metres
Health:	Fair
Structure:	Good
Form:	Good
Trunk Circumference:	>2 metres
Useful Life Expectancy:	>10 years

This tree is considered to be in fair overall condition due to its moderately reduced health rating associated the impact of bat activity in the upper sections of the crown. This tree is identified as part of the bat roost and is marked as Tree 143.

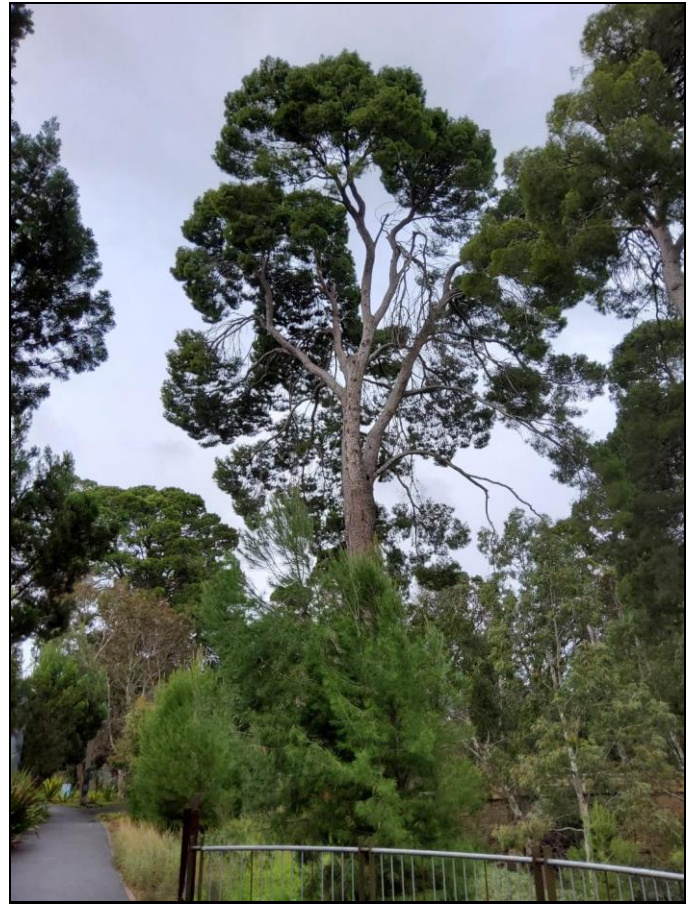
Aleppo Pine

Inspected:	6 July 2023
Height:	>20 metres
Spread:	>20 metres
Health:	Good
Structure:	Good
Form:	Good
Trunk Circumference:	>3 metres
Useful Life Expectancy:	>20 years

This tree displays a minor history of branch failure however this has not noticeably impacted the tree's structure and it displays good health indicating it is in otherwise good condition. This tree is identified as part of the bat roost and is marked as Tree 132. A large failed branch is hanging in the upper crown on the river side of this tree.

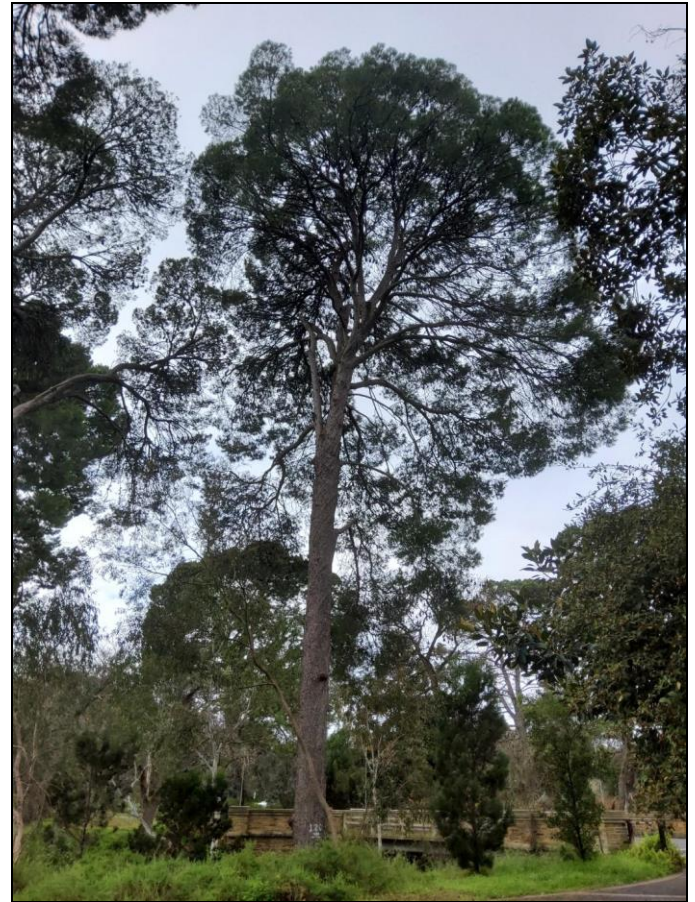
Aleppo Pine

Inspected:	6 July 2023
Height:	>20 metres
Spread:	>20 metres
Health:	Good
Structure:	Good
Form:	Good
Trunk Circumference:	>3 metres
Useful Life Expectancy:	>20 years

The health and structure of this tree indicate it is in good overall condition and has adapted to its local environment. This tree is identified as part of the bat roost and is marked as Tree 120.

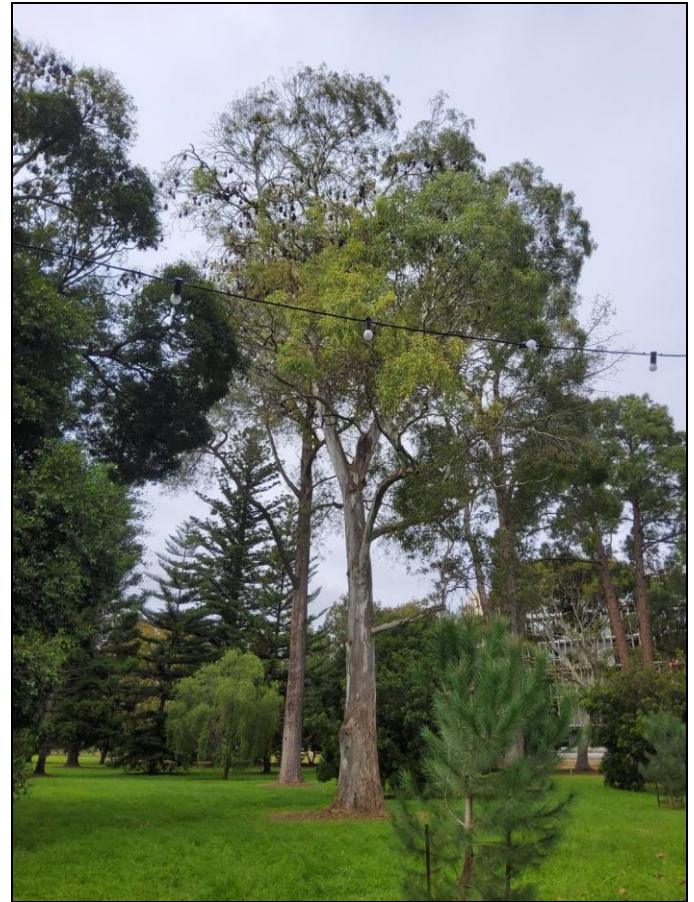
River Red Gum

Inspected:	6 July 2023
Height:	>20 metres
Spread:	>20 metres
Health:	Fair
Structure:	Good
Form:	Good
Trunk Circumference:	>3 metres
Useful Life Expectancy:	>10 years

This tree is considered to be in fair overall condition due to its moderately reduced health rating associated with the impact of bat activity in the upper sections of the crown.

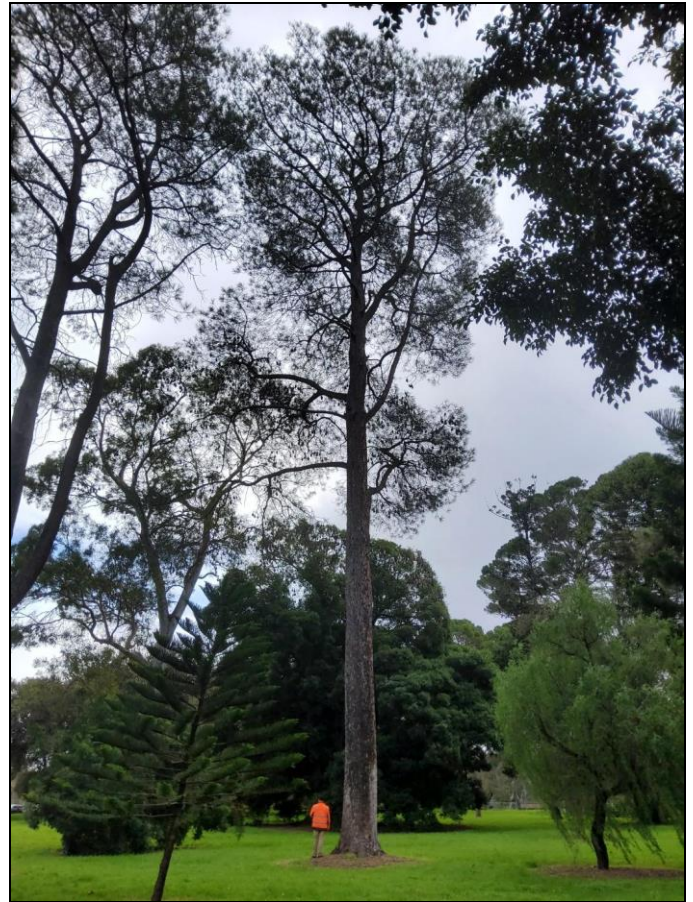
Torrey Pine

Inspected:	6 July 2023
Height:	>20 metres
Spread:	>20 metres
Health:	Good
Structure:	Good
Form:	Good
Trunk Circumference:	>3 metres
Useful Life Expectancy:	>20 years

The health and structure of this tree indicate it is in good overall condition and has adapted to its local environment.

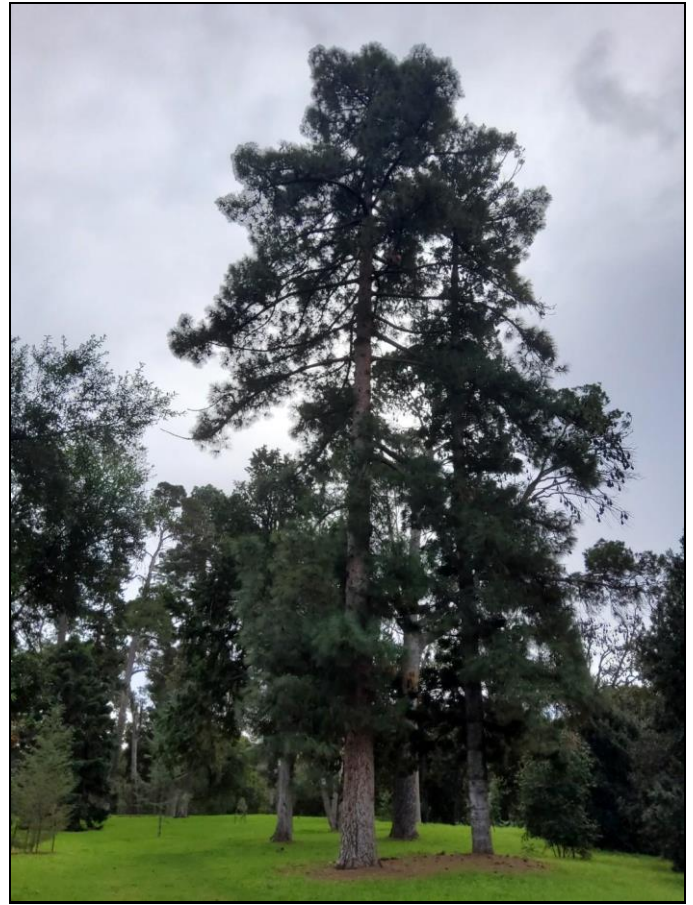
Stone Pine

Inspected:	6 July 2023
Height:	>20 metres
Spread:	>20 metres
Health:	Good
Structure:	Good
Form:	Good
Trunk Circumference:	>2 metres
Useful Life Expectancy:	>20 years

The health and structure of this tree indicate it is in good overall condition and has adapted to its local environment.

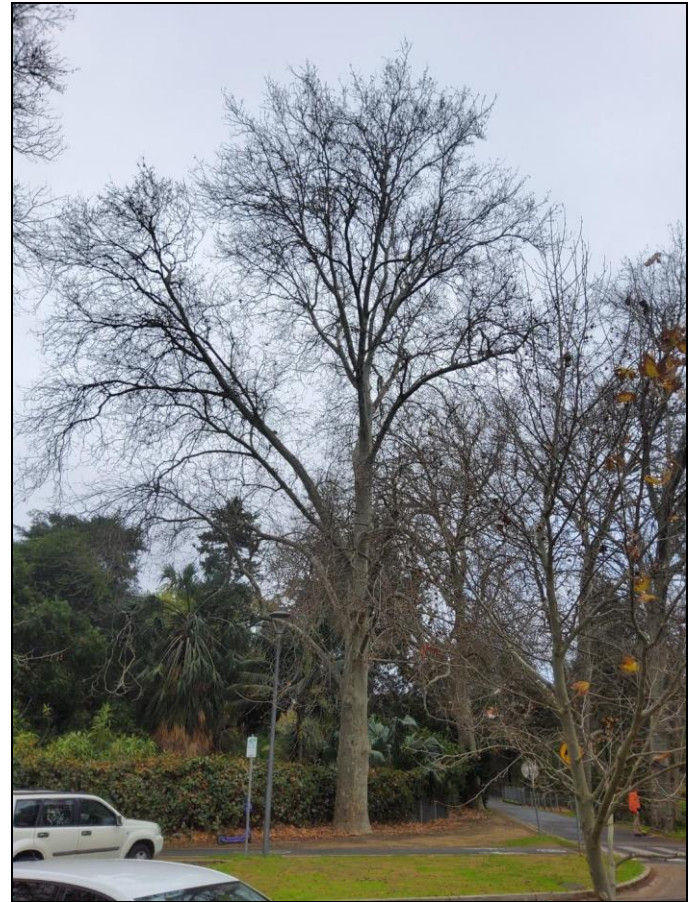
London Plane

Inspected:	6 July 2023
Height:	>20 metres
Spread:	>20 metres
Health:	Good
Structure:	Good
Form:	Good
Trunk Circumference:	>3 metres
Useful Life Expectancy:	>20 years

The health and structure of this tree indicate it is in good overall condition and has adapted to its local environment. There is some damage from bird activity to the leading stem and primary branch unions in the upper crown however this is not impacting the overall structure of the tree.

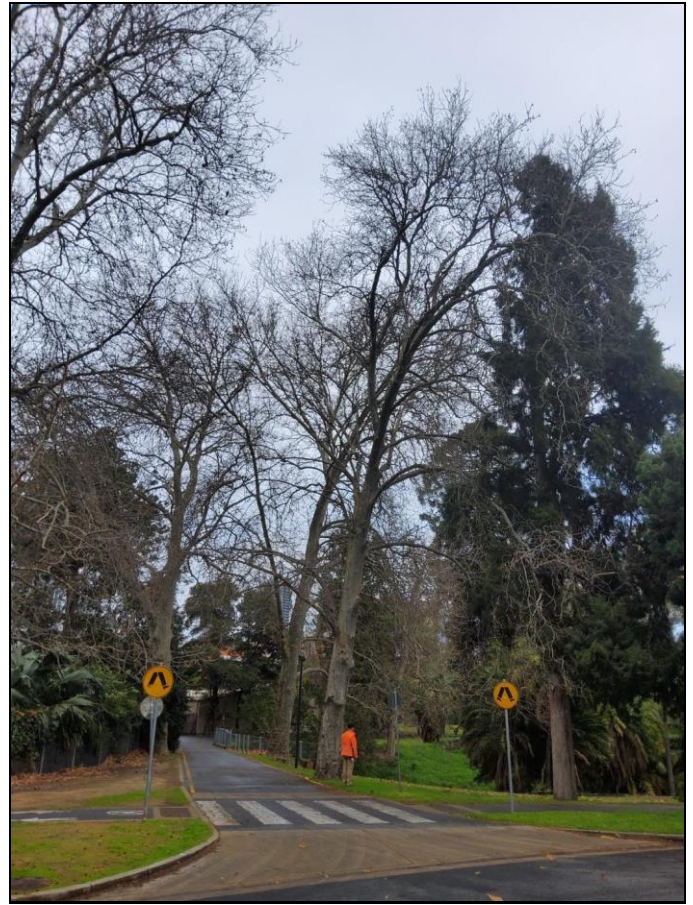
London Plane

Inspected:	6 July 2023
Height:	>20 metres
Spread:	>20 metres
Health:	Good
Structure:	Good
Form:	Good
Trunk Circumference:	>2 metres
Useful Life Expectancy:	>20 years

The health and structure of this tree indicate it is in good overall condition and has adapted to its local environment. There is some damage from bird activity to the leading stem and primary branch unions in the upper crown however this is not impacting the overall structure of the tree.

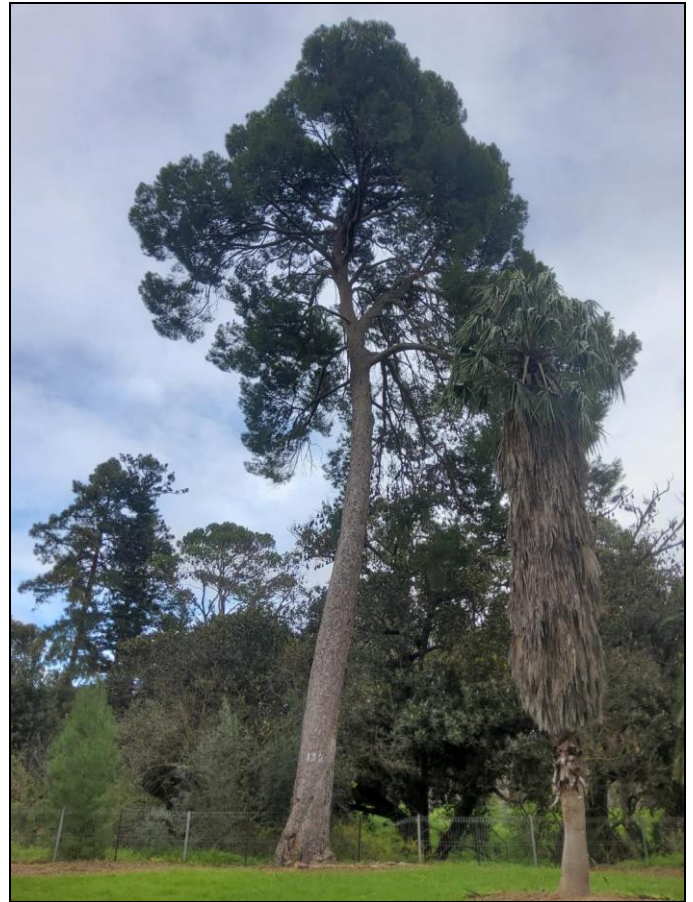
Aleppo Pine

Inspected:	6 July 2023
Height:	>20 metres
Spread:	>20 metres
Health:	Good
Structure:	Good
Form:	Good
Trunk Circumference:	>3 metres
Useful Life Expectancy:	>20 years

The health and structure of this tree indicate it is in good overall condition and has adapted to its local environment. This tree is identified as part of the bat roost and is marked as Tree 152. There is a wound at the base of this tree with good response wood surrounding it and no evidence of decay.

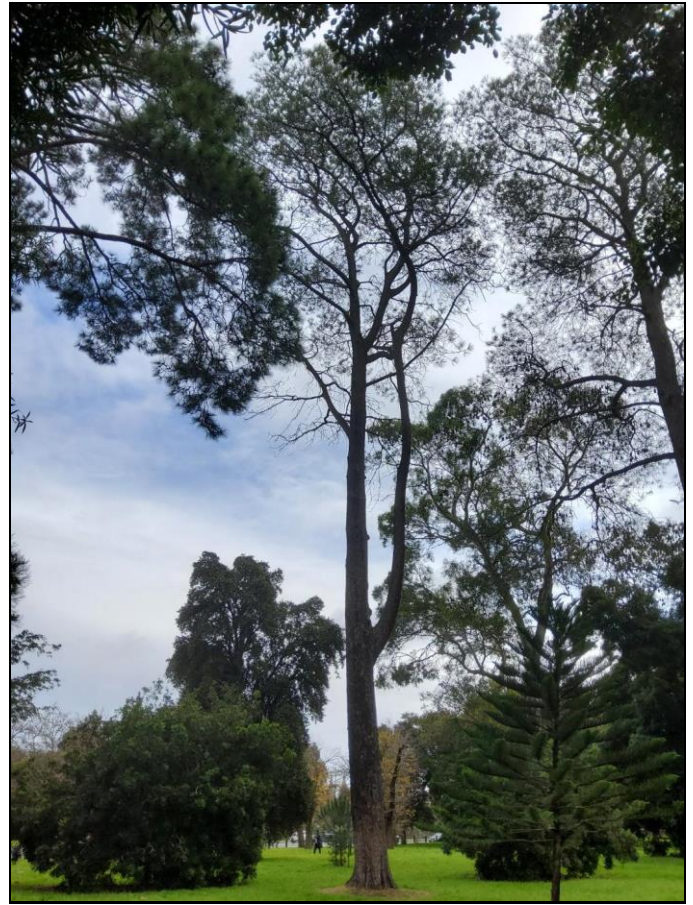
Torrey Pine

Inspected:	6 July 2023
Height:	>20 metres
Spread:	>20 metres
Health:	Fair
Structure:	Good
Form:	Good
Trunk Circumference:	>3 metres
Useful Life Expectancy:	>10 years

This tree is considered to be in fair overall condition due to the volume of deadwood, reduced foliage density and level of dieback in parts of the crown. Additionally, one of the primary branches has died.

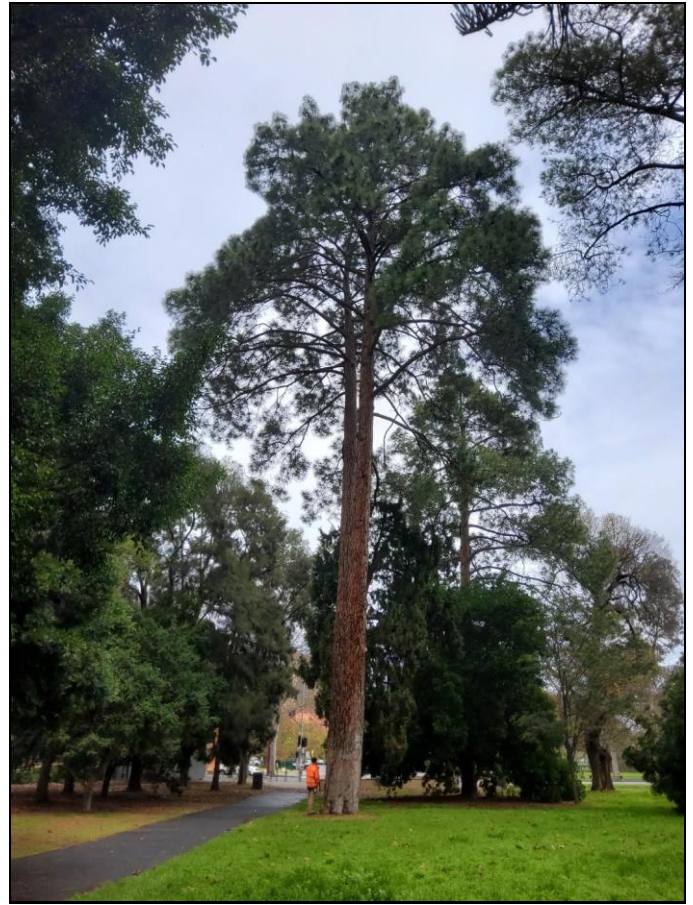
Canary Island Pine

Inspected:	6 July 2023
Height:	>20 metres
Spread:	>20 metres
Health:	Good
Structure:	Good
Form:	Fair
Trunk Circumference:	>3 metres
Useful Life Expectancy:	>20 years

The health and structure of this tree indicate it is in good overall condition and has adapted to its local environment. There is evidence of early stage included bark however this is not significant or impacting the structural rating for this tree. The Form rating is reduced to Fair as it has co-dominant leading stems. This tree is identified as part of the bat roost and is marked as Tree 101.

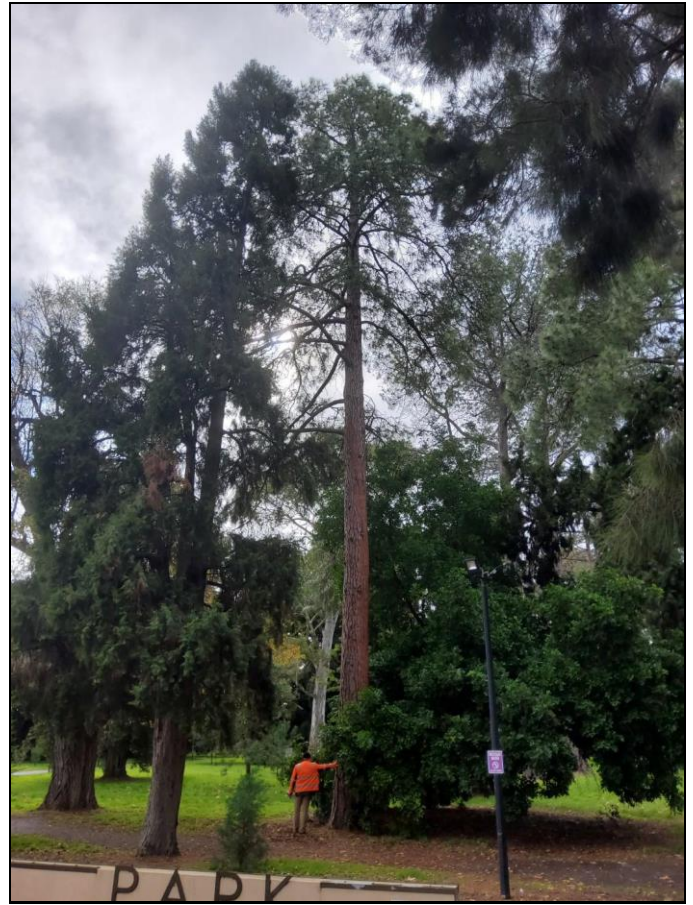
Canary Island Pine

Inspected:	6 July 2023
Height:	>20 metres
Spread:	>20 metres
Health:	Good
Structure:	Good
Form:	Good
Trunk Circumference:	>2 metres
Useful Life Expectancy:	>20 years

The health and structure of this tree indicate it is in good overall condition and has adapted to its local environment. This tree is identified as part of the bat roost and is marked as Tree 06.

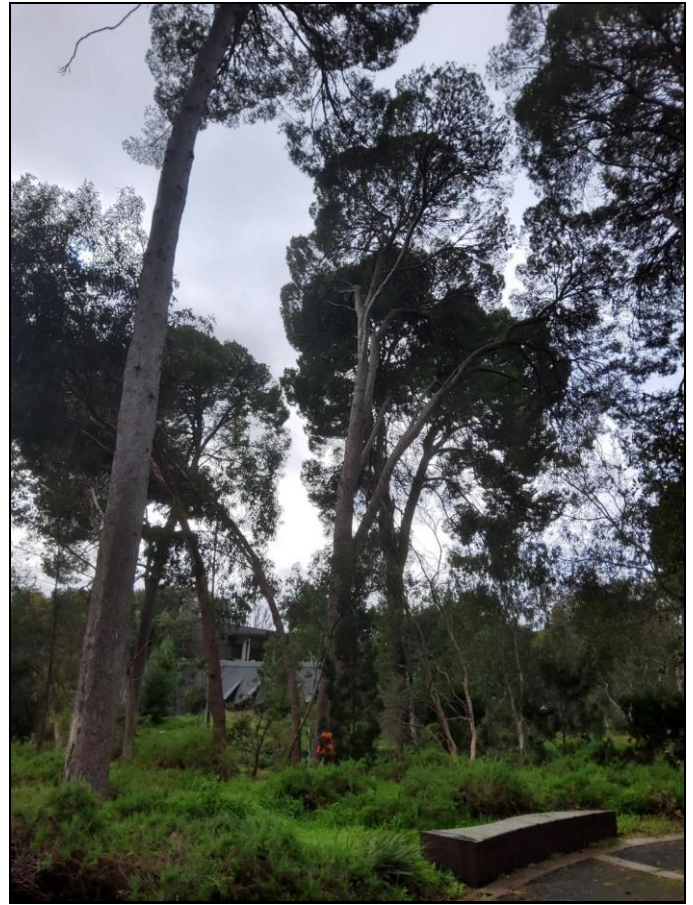
Aleppo Pine

Inspected:	6 July 2023
Height:	>20 metres
Spread:	>20 metres
Health:	Good
Structure:	Good
Form:	Good
Trunk Circumference:	>2 metres
Useful Life Expectancy:	>20 years

The health and structure of this tree indicate it is in good overall condition and has adapted to its local environment. This tree is identified as part of the bat roost and is marked as Tree 121.

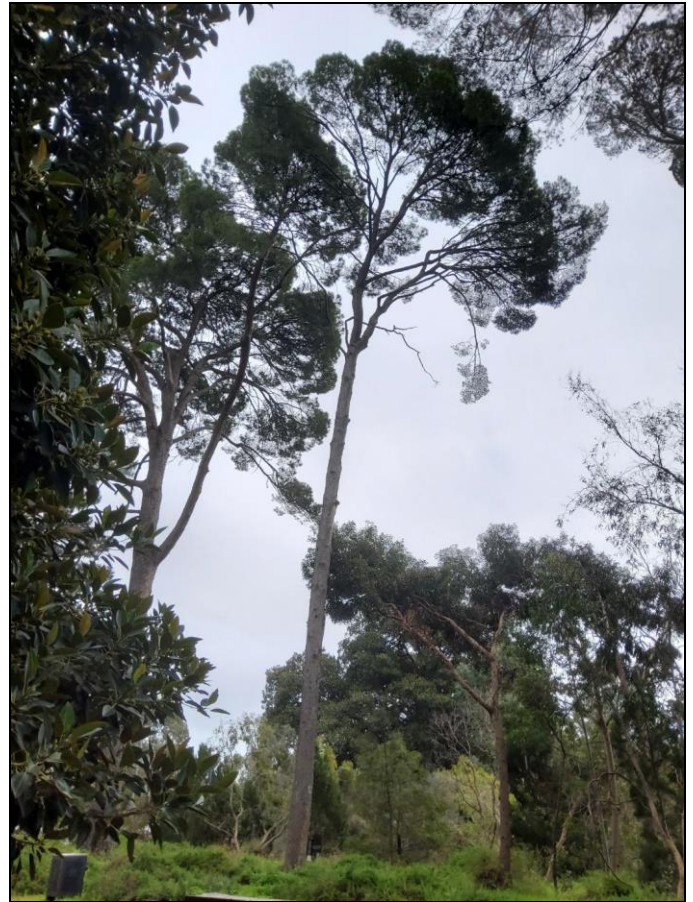
Aleppo Pine

Inspected:	6 July 2023
Height:	>20 metres
Spread:	>20 metres
Health:	Good
Structure:	Good
Form:	Good
Trunk Circumference:	<2 metres
Useful Life Expectancy:	>20 years

The health and structure of this tree indicate it is in good overall condition and has adapted to its local environment. This tree is identified as part of the bat roost and is marked as Tree 122.

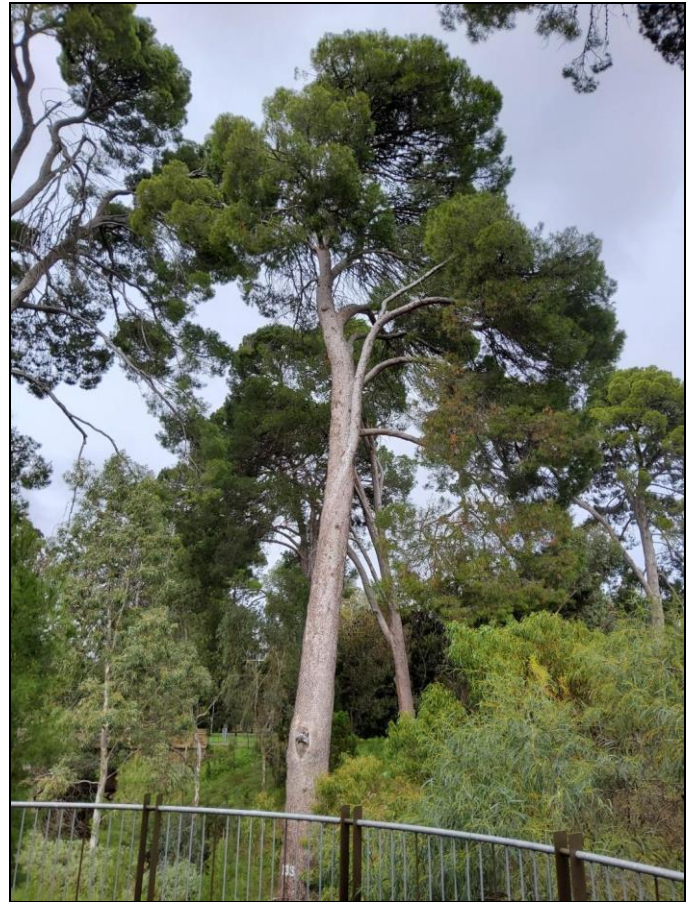
Aleppo Pine

Inspected:	6 July 2023
Height:	>20 metres
Spread:	<5 metres
Health:	Good
Structure:	Good
Form:	Good
Trunk Circumference:	>2 metres
Useful Life Expectancy:	>20 years

The health and structure of this tree indicate it is in good overall condition and has adapted to its local environment. This tree is identified as part of the bat roost and is marked as Tree 133.

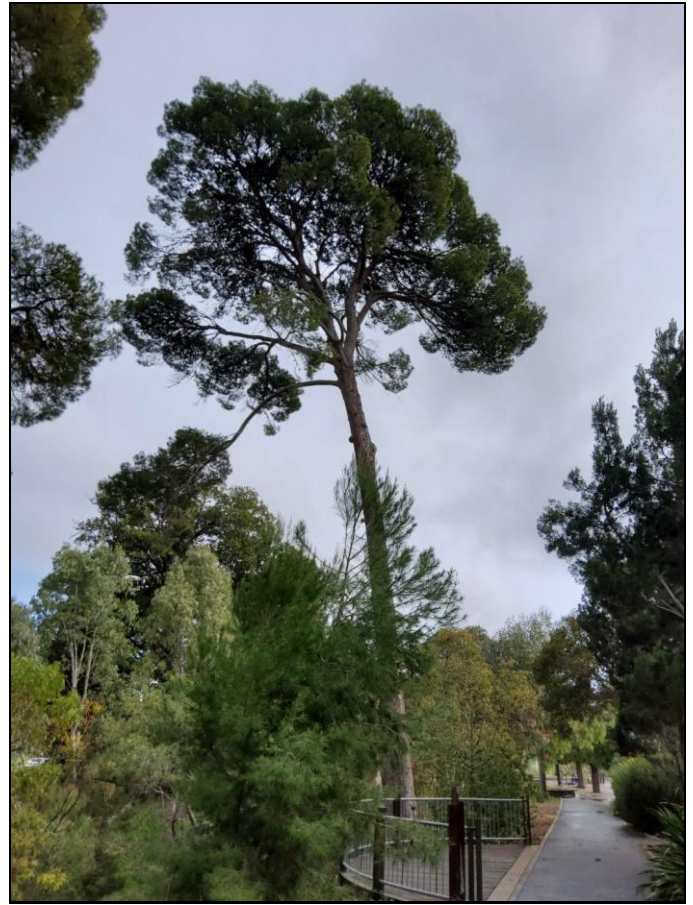
Aleppo Pine

Inspected:	6 July 2023
Height:	>20 metres
Spread:	>20 metres
Health:	Good
Structure:	Good
Form:	Good
Trunk Circumference:	>2 metres
Useful Life Expectancy:	>20 years

The health and structure of this tree indicate it is in good overall condition and has adapted to its local environment. This tree is identified as part of the bat roost and is marked as Tree 134.

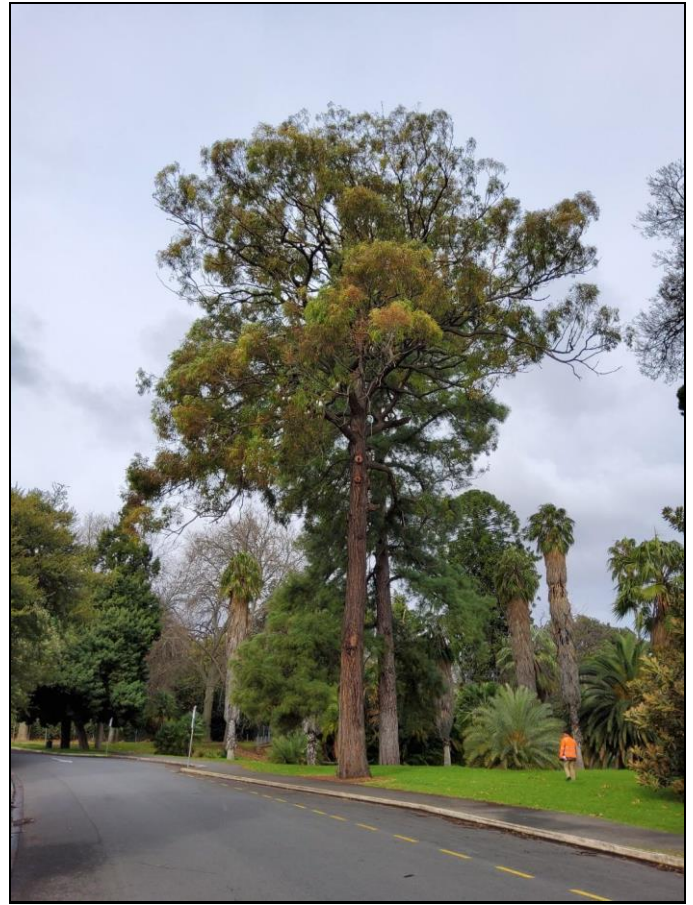
Mugga Ironbark

Inspected:	6 July 2023
Height:	>20 metres
Spread:	15-20 metres
Health:	Fair
Structure:	Good
Form:	Good
Trunk Circumference:	>3 metres
Useful Life Expectancy:	>10 years

This tree is considered to be in fair overall condition as evidenced by the slightly reduced foliage density and moderate history of small to medium diameter branch failure. This tree is identified as part of the bat roost and is marked as Tree 151.

Legislative Status	Exempt
Trees on this site are exempt from control under the Planning, Development and Infrastructure Act 2016 as per Schedule 4—Exclusions from definition of development—general, Part 18, (1), (d) of the Planning, Development and Infrastructure (General) Regulations 2017.	
Risk Rating	Low
A Likelihood of Failure and Impact of "Unlikely" and a Consequence of "Minor" when combined in the Risk matrix achieve a Risk Rating of "Low".	
Action	Monitor
This tree should be monitored for further health decline on an annual basis. Additionally, improvements to the root zone of this tree are recommended.
