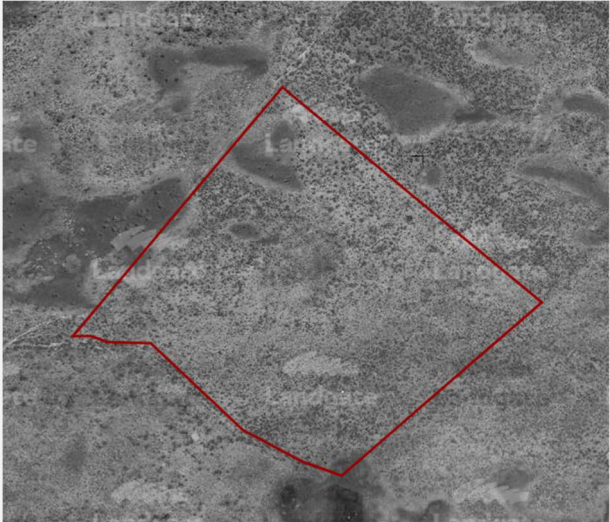
Date and Description	Image
<p>30/10 – 27/11/1953</p> <p>Earliest available aerial imagery. Site is comprised of vegetation without evidence of clearing.</p>

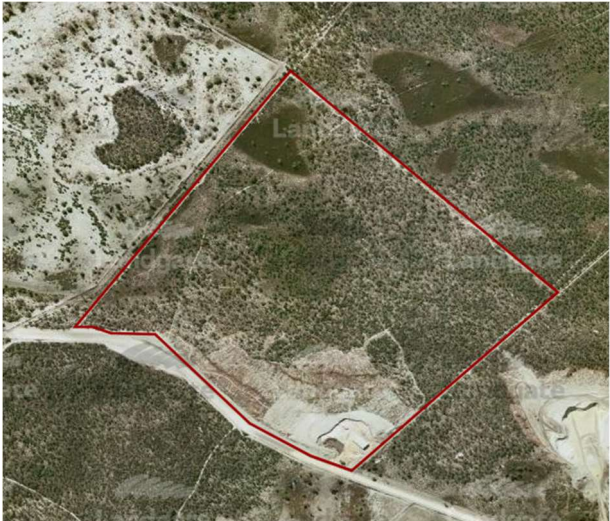
<p>20/04-19/06/1985</p> <p>Clearing for sand mining operations commenced in southeastern corner.</p>

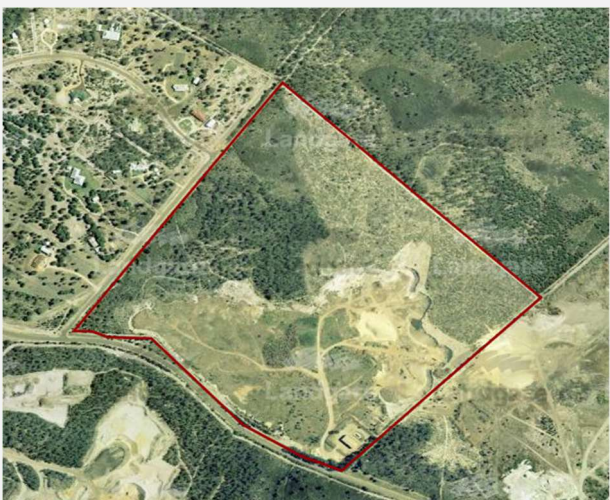
<p>03/01-24/02/2000</p> <p>Clearing and sand mining has progressed to the centre and east. Landform has been reinstated in southeast corner.</p>

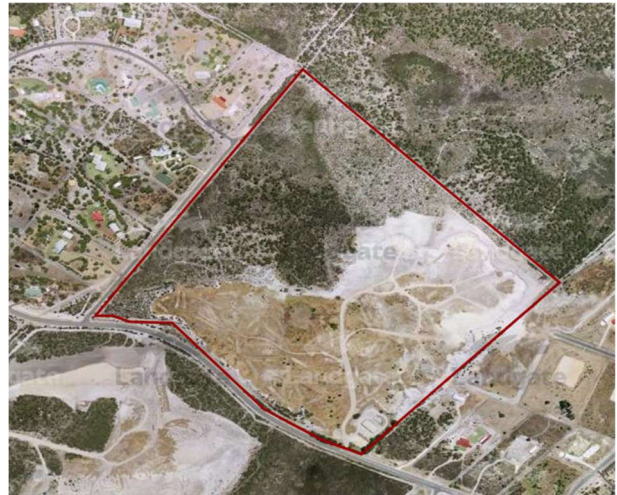
17-24/12/2005  
Clearing continues further north.

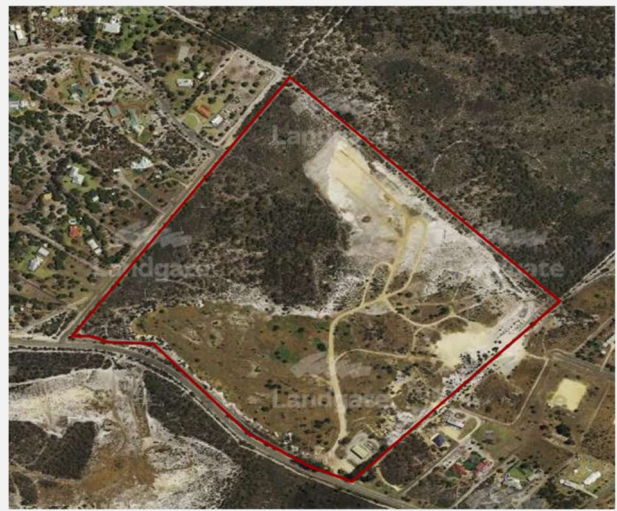
20/11/2011  
Clearing continues further northwest. Landform reinstated to the south. Vegetation has started to regrow in the south.

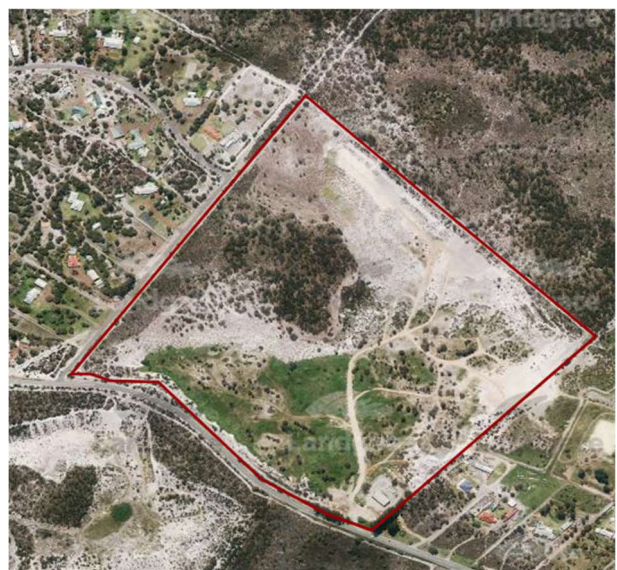
17-22/09/2015  
Clearing has affected majority of the Project Area excluding the centre.

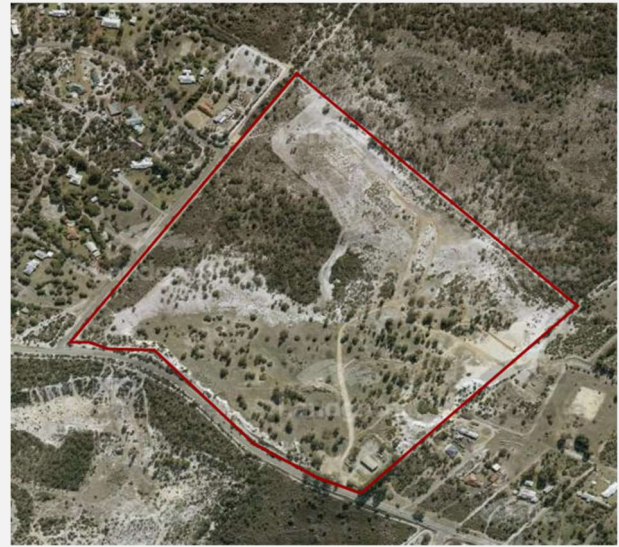
12/05-08/07/2018  
Maximum extent of clearing reached, vegetation continues to regrow in south and centre of the Project Area.

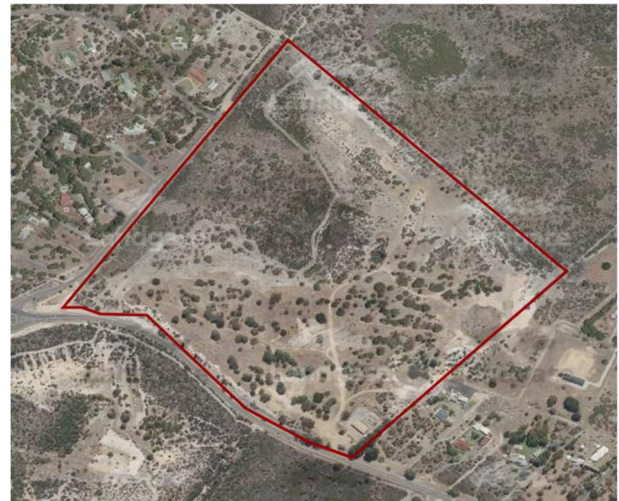
05-16/02/2025  
Current condition of the Project Area.
