# **OLD GYMPIE ROAD UPGRADE (KALLANGUR - DAKABIN):**

## **Cultural Heritage Assessment**

For the Kabi Kabi People & Moreton Bay Regional Council

May 2023

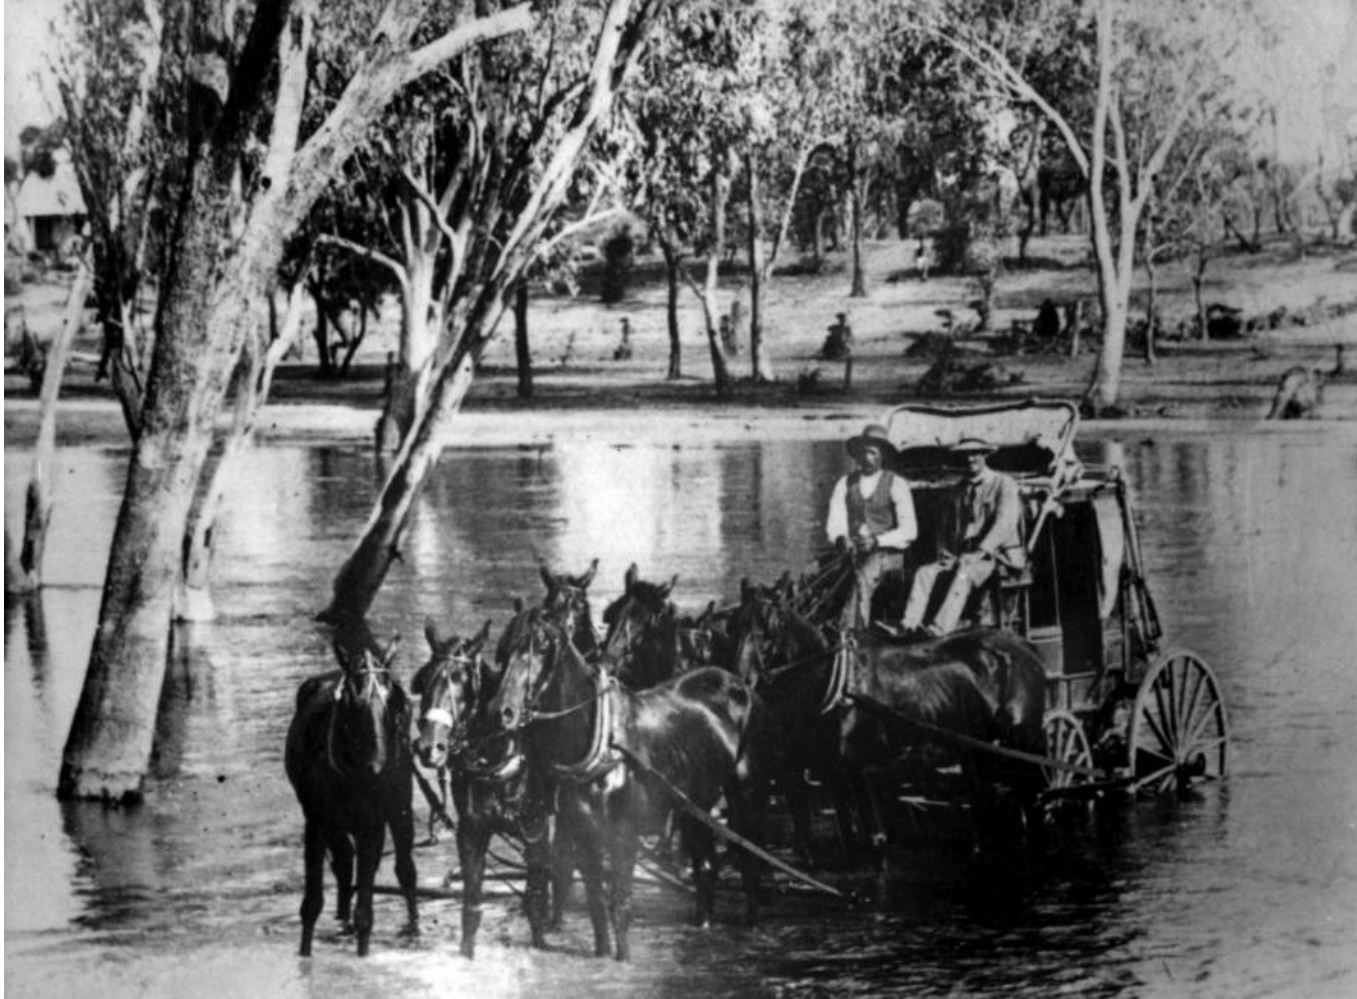
Figure 4: Cobb & Co. coach crossing the long logging [corduroy road] on Gympie Road, North Pine district (now Kallangur), mid 1880s (Courtesy Moreton Bay Region Libraries - Reference number PRLPC-P0193). "The flooded area in the photograph has been identified as the long logging [corduroy road] on Freshwater Creek, one of many similar areas where saplings were laid on boggy road sections of the road to build up the carriage way. The corner of Brickworks Road and Old Gympie Road would be just beyond the tree behind the coach." This image thus looks southeast in the direction of the Old Gympie Road/Anzac Avenue intersection.

Figure 4 and Figure 5 illustrate the historic land clearance practices at the site. Figure 4 shows the Old Gympie Road crossing over, or rather under, Freshwater Creek in the mid-1880s. Figure 5 shows an aerial photograph of the Project area in 1957, and clearly illustrates that by 1957 the road reserve had seen some clearance of trees, especially closer to the Anzac Avenue intersection.

**Note:** While Historical Archaeology was outside the scope of the current project, there is limited potential for the remains of the corduroy road across Freshwater Creek, to be present within the vicinity of the future culvert upgrade.

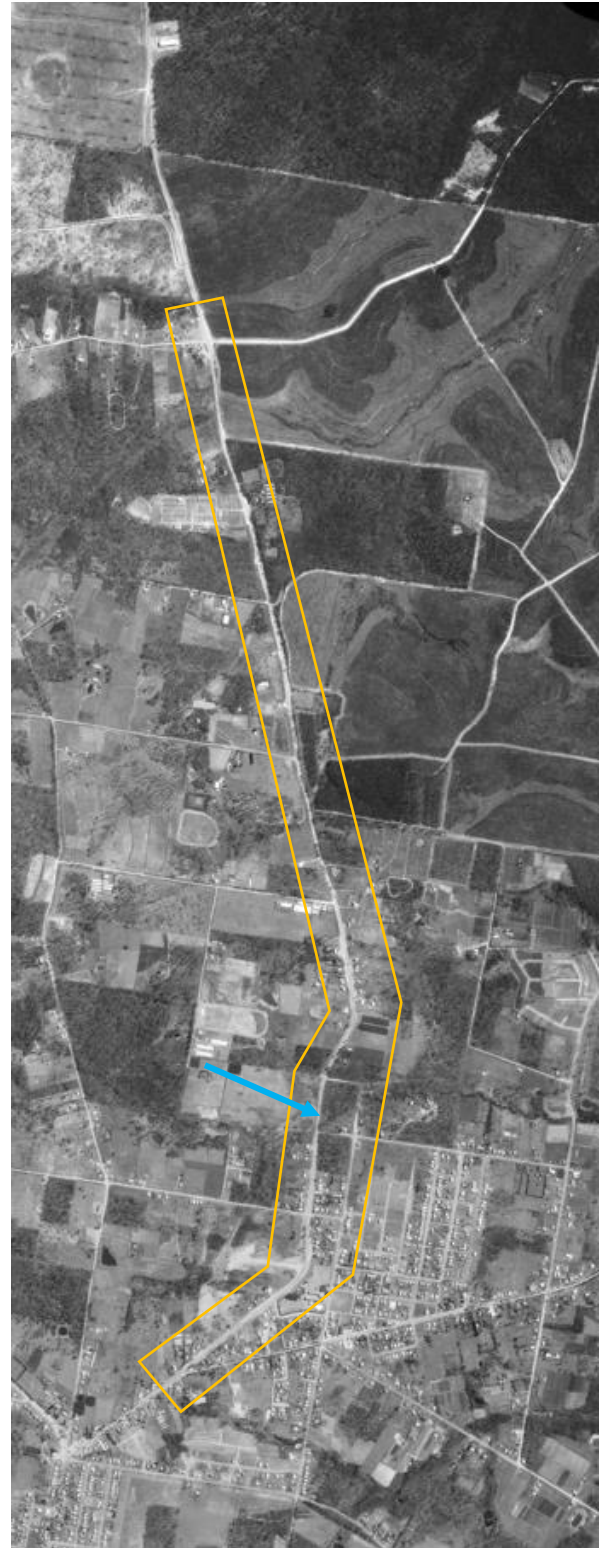
Figure 6: 1949 Historical Aerial (Courtesy QImagery 2023). The Project area is outlined in Yellow, and the Freshwater Creek Crossing is indicated by the blue arrow.

- By 1949 parts of the road corridor has been cleared for agricultural purposes, with clearing activity concentrated towards the Old Gympie Road/Anzac Avenue intersection in the south (Figure 6).

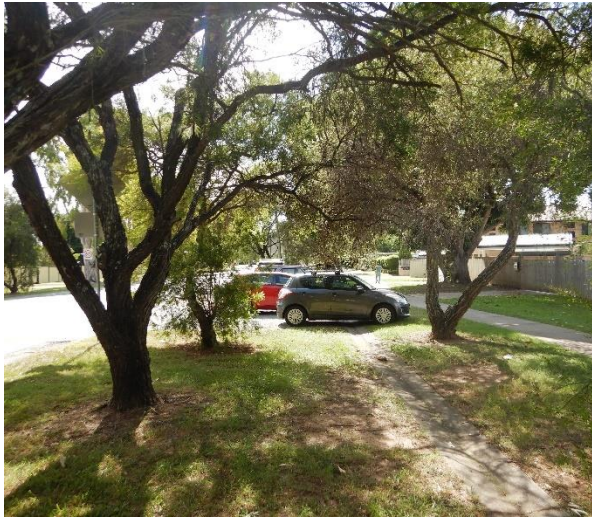
Figure 9: An example of Poor GI (historically cleared and built up) and Poor GSV (due to turfing and the road surface).

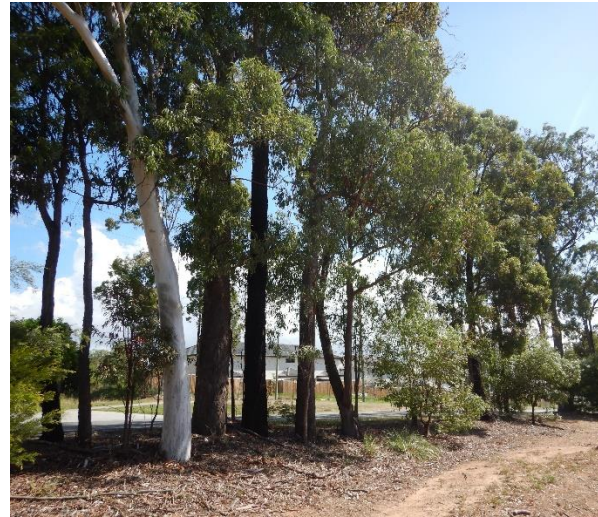
Figure 10: An example of Fair GI (remnant vegetation on the road verge) and Good GSV (due to erosion).

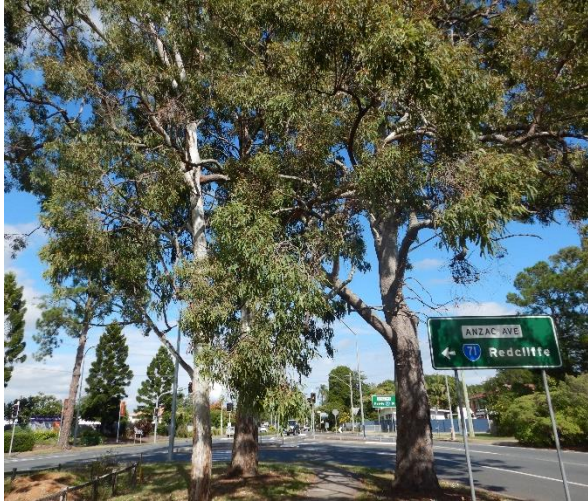
Figure 11: Map of recorded points within the Project area.

The assessment targeted those areas where current plans indicate remnant vegetation will be removed and resulted in a number of culturally significant places and values being recorded. These included significant trees, habitat trees, and resource areas. Their location is shown in Figure 11 and details presented in Table 4, Chapter 4.5 including management/mitigation strategies determined in the field by the Kabi Kabi representatives. Figures 12-21 show views of the various trees, and points of interest, recorded during the survey.

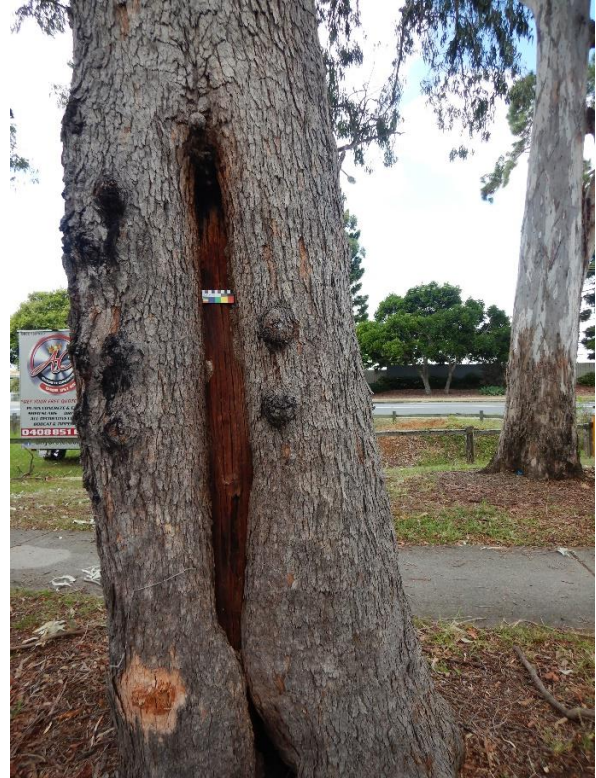
Figure 13: Bloodwood tree at OGR-01 with a large scar facing the road. This scar was determined to be not cultural in origin, based on its size, and the fact that the scar starts at ground level. A native beehive was located at the apex of the scar.

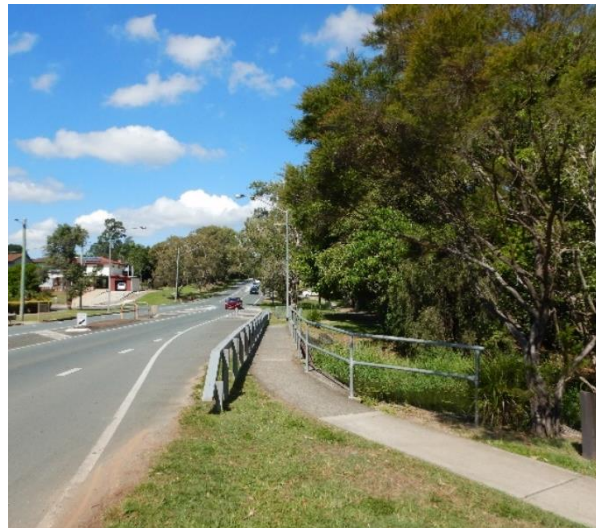
Figure 15: OGR-04 showing the culvert over Freshwater Creek, looking south. A grey headed? flying fox colony was identified approx. 50m to the west/upstream (to the right of the picture).

During the survey a grey headed? flying fox colony was identified approximately 50m upstream (west) from the Freshwater Creek culvert. This species is listed as vulnerable. Kabi Kabi representatives expressed concern for the welfare of the colony, and it is recommended that a copy of the faunal report for the Project area be provided to them by MBRC. Kabi Kabi representatives noted that it is important to capture the presence of the colony in the faunal report and the potential impacts of works on the colony. As nocturnal animals, it is also critical to mitigate the impacts of night works on the colony.

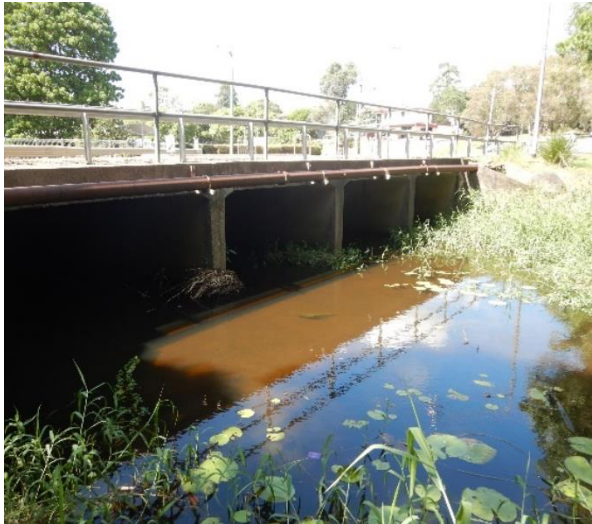
Figure 16: The Freshwater Creek Culvert will be widened. There is a limited potential for early historical fabric to remain in this area.

While historical archaeology was outside the scope of the current project, it should be noted that there is limited potential for the remains of the corduroy road across Freshwater Creek to be present within the vicinity of the future culvert upgrade between the Brickworks Rd and Roseann Str intersections. It is, therefore, recommended that MBRC develop and implement a Historical Archaeology - New Finds Process for works in this location.

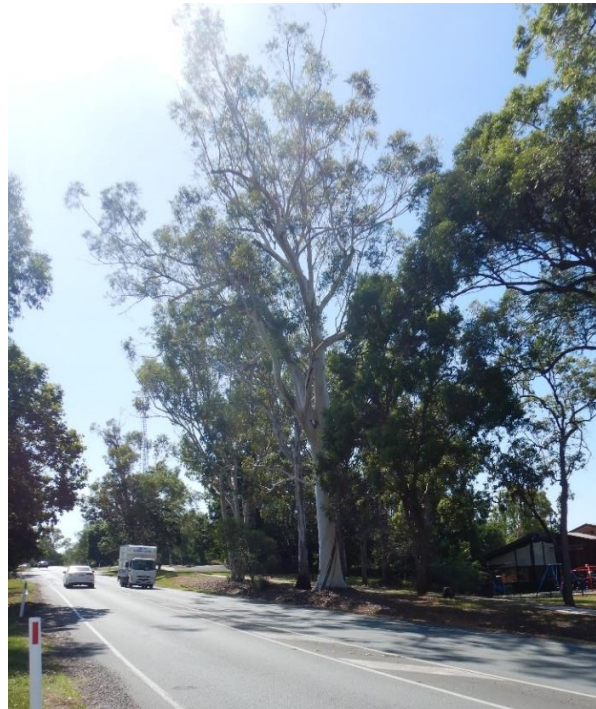
Figure 17: Large remnant scribbly gum tree at OGR-05, looking north. This tree is highly significant to the Kabi Kabi People.

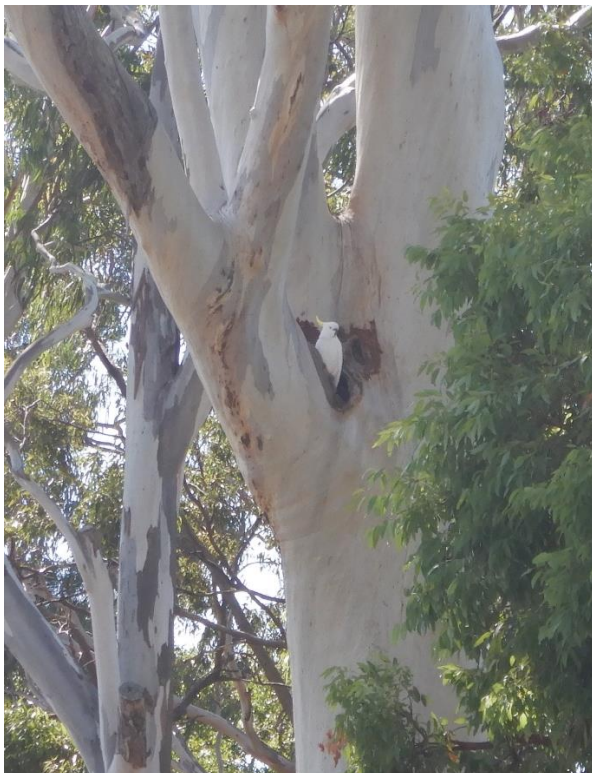
Figure 18: Tree hollow present in the large scribbly gum (OGR-05). Occupied by a sulphur crested cockatoo. Hollows large enough for these big birds, take approximately 270 years to form in scribbly gum (Wormington and Lamb 1999:342). This tree is highly significant to the Kabi Kabi People.

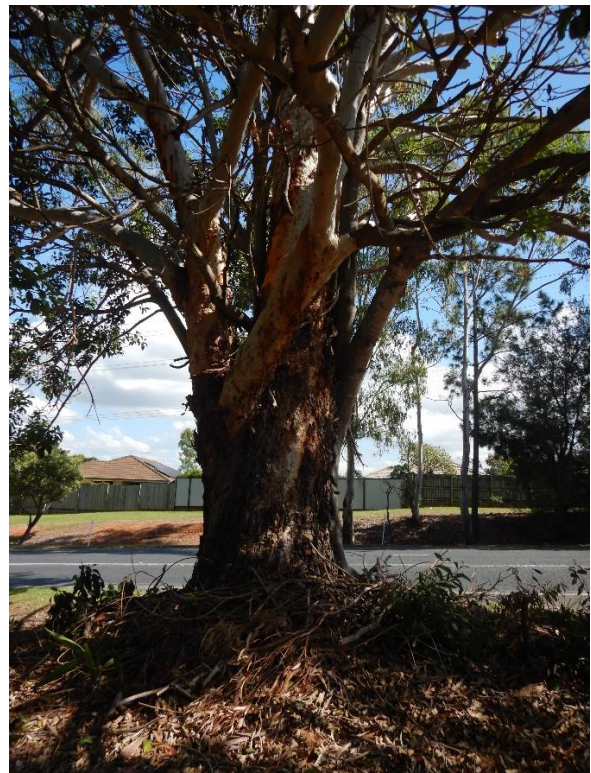
Figure 19: Large, truncated, gum tree with visible regrowth, at OGR-06.

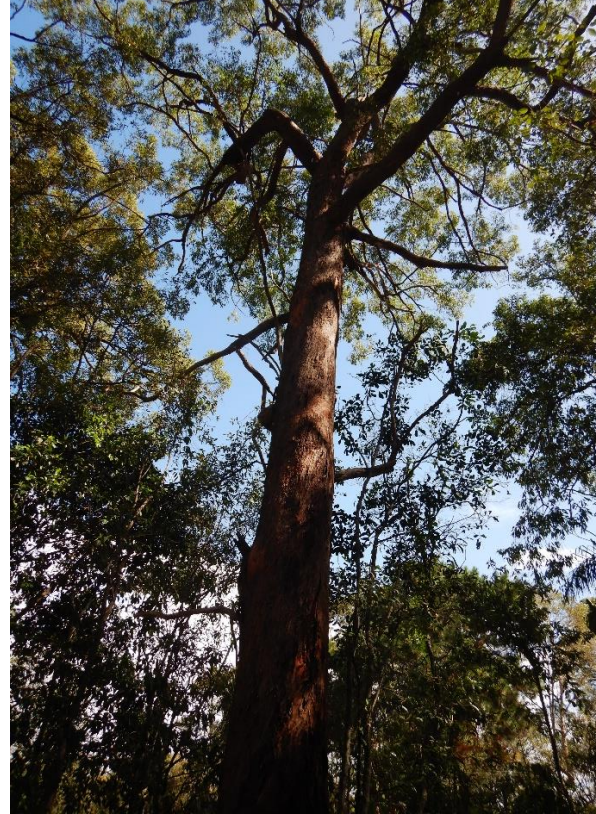
Figure 20: Stand of remnant tallowwood and gum trees at OGR-09.
